## OPERATING MANUAL

## Introduction

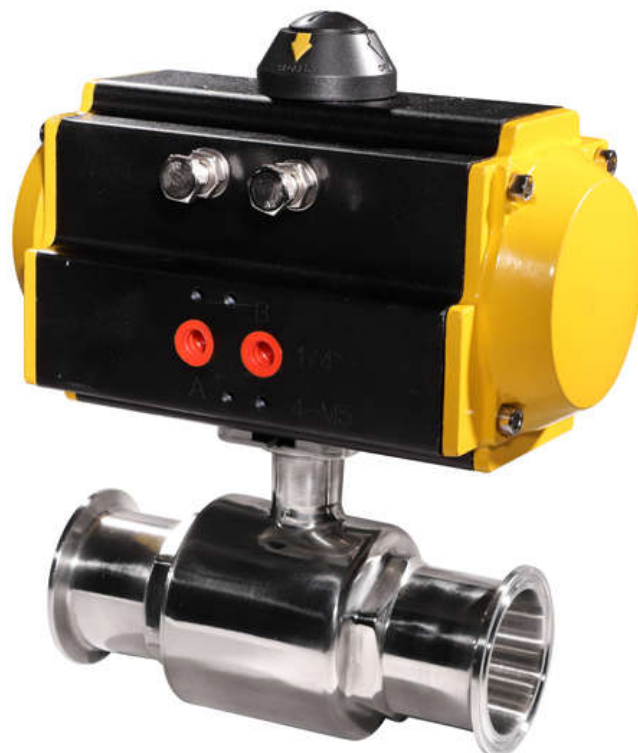
The 3 piece design allows for the center part of the valve containing the ball, stem & seats to be easily removed from the pipeline. This facilitates efficient cleaning of deposited sediments, replacement of seats and gland packings, polishing out of small scratches on the ball, all this without removing the pipes from the valve body. The design concept of a three piece valve is for it to be repairable.

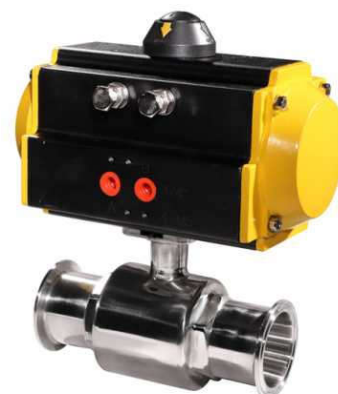
| Double acting | Air to open, air to close, air supply failure to keep the current position |
| Single Acting N/C | Air to open, interrupt air to close, air failure to close |
| Single Acting N/O | Air to close, interrupt air to open, air failure to open |

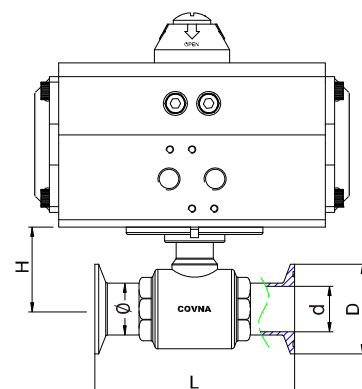
## Qutine Size drawing

UNIT: mm

| Size | 1/2" | 3/4" | 1" | 1-1/4" | 1-1/2" | 1-3/4" | 2" | 2-1/4" | 2-1/2" | 3" | 3-1/2" | 4" |
| Ø | 16 | 19.05 | 25.4 | 31.8 | 38.1 | 45 | 50.8 | 57 | 63.5 | 76.5 | 89.1 | 101.6 |
| d | 16 | 22 | 29 | 35 | 42 | 48 | 53 | 59 | 72 | 85 | 97 | |
| D | 25.4 | 50.5 | 50.5 | 50.5 | 50.5 | 64 | 64 | 77.5 | 77.5 | 91 | 106 | 119 |
| L | 75 | 103 | 116 | 122.5 | 136 | 146 | 161 | 170 | 178 | 200 | 210 | 249 |
| H | 27 | 38 | 46.5 | 49 | 53.5 | 58 | 68 | 60 | 68.5 | 78 | 89.5 | 103.5 |
| Actuator | AT52 | AT52 | AT52 | AT52 | AT63 | AT63 | AT75 | AT83 | AT83 | AT92 | AT105 | AT125 |

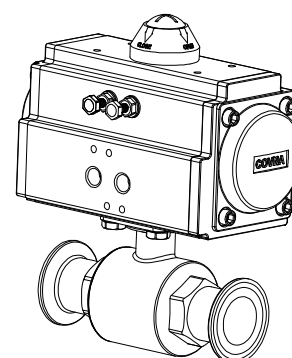
- Tightening the seal between the valve and the actuator:  
Remove the four bolts underneath the actuator. Separate the actuator from the valve.  
Tighten the nut on the top of the valve body.  
Place the actuator back on the valve and screw everything back into place.
- Tightening the seals between the valve and the inlet/outlet ports:  
Remove the torque bolts and check for any debris or damage to the gaskets.  
Use a torque wrench or other consistent method of tightening the torque bolts to reconnect the inlet and outlet ports.

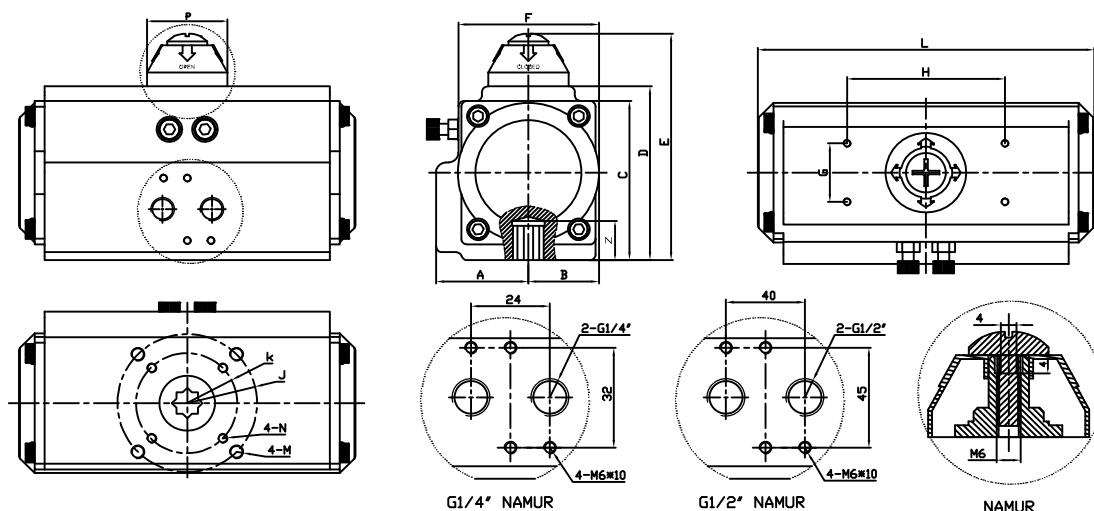
### Outline Size drawing

| MODEL | A | B | C | D | E | F | G | H | J | K | N | M | L | P | Z | Air Hole |
| AT52 | 30 | 42.5 | 65.5 | 72.4 | 92.5 | 50.5 | 30 | 80 | Ø36 | Ø50 | M5×8 | M6×10 | 150 | 42 | 14 | NAMUR G1/4" |
| AT63 | 36 | 47 | 81 | 88.5 | 98.5 | 69.5 | 30 | 80 | Ø50 | Ø70 | M6×10 | M8×13 | 171 | 42 | 18 | NAMUR G1/4" |
| AT75 | 42.5 | 53 | 93 | 100 | 120 | 78 | 30 | 80 | Ø50 | Ø70 | M6×10 | M8×13 | 186 | 42 | 18 | NAMUR G1/4" |
| AT83 | 46.5 | 57 | 98.5 | 109.7 | 129.5 | 86 | 30 | 80 | Ø50 | Ø70 | M6×10 | M8×13 | 206 | 42 | 21 | NAMUR G1/4" |
